Property Facts Home & Energy Inspections. 9350 Colony Farms Ct; Plymouth, MI 48170

October 20, 2016

RE: 1997 W. Wheeling Lane
Bloomfield Hills, MI 48304

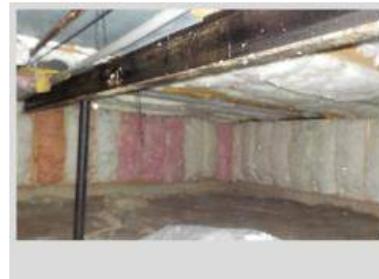
Crawl space Location & Accessibility: Location: Basement. A proper crawl space entrance cover is lacking.

Crawl Space Area & Conditions Viewed: Overall condition of crawlspace appears good. Area appears dry. Crawlspace ground area is - dirt. A proper vapor barrier is not applied.

Observations/Recommendations: The following are recommendations for a good crawl space area: A proper access door should be applied. A proper vapor barrier should be added on ground surface.

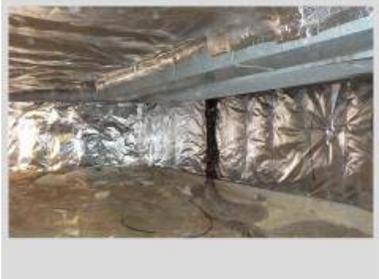
Insulation:	Insulation appear serviceable.	
Lighting Fixtures & Outlets:	None. Recommend upgrading the crawlspace area to a lighting system that meets today's current requirements.	
Observations/Recommendations:	The following are recommendations for a good crawl space area: A proper access door should be applied. A vapor barrier should be added on ground surface. Insulation should be installed - Exterior walls, under floor joist, plumbing water supply lines and/or ductwork as needed.	
Crawl space Location & Accessibility:	Location: Basement. A proper crawl space entrance cover is lacking.

Crawl Space Area & Conditions Viewed:	Overall condition of crawlspace appears good. Area appears dry. Crawlspace ground area is - dirt. A proper vapor barrier is not applied.	
Foundation Walls-Type Condition - Walls:	Poured concrete. Appears serviceable. Some areas were not fully visible due to - The area appears to have had some conditioning work, improvement made.

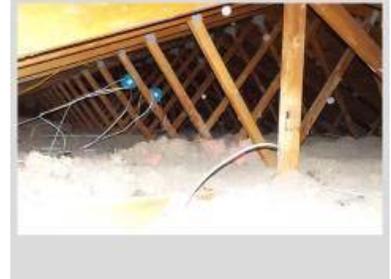
The attic is Partial. The attic was entered through the - Bedroom closet. Noted: The access cover is not adequately covered and attached by insulation and or weather stripping applied, this is highly recommended to prevent heat loss.

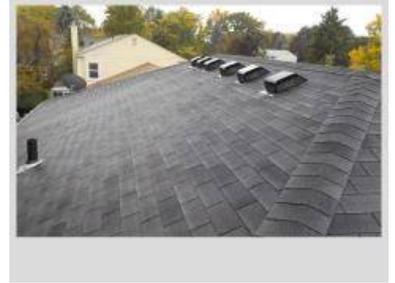
The roof covering on the main structure appears to be the second covering. Current building standards will allow only two coverings. When re roofing again, it will be necessary to remove the first two layers. **SECOND LAYER OF SHINGLES PRESENT:** Shingles installed as a second layer over other shingles generally have a shortened service life, a result of deterioration which occurs as a function of heat retention of the shingle mass. Second layer shingles usually wear out 2-3 years sooner than shingles installed as a first layer. Drip edge which is a metal strip installed on roofs to extend shingles further over the roof edge was in place. Unable to fully identify that ice shield was installed on roof due two layers of shingles. Ice shield is applied which is a

Satisfactory - The roof covering material is in a condition that is consistent with its age and method of installation, showing no deficiency or cause for immediate concern.

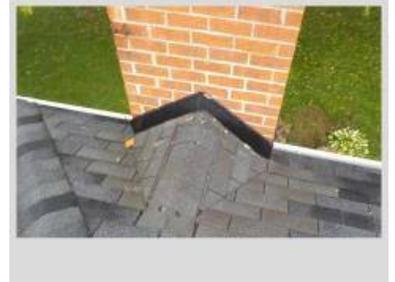
Metal. Satisfactory - The flashings around openings in the roof covering appear to be watertight and caulked as needed. There is a cricket installed. It appears to be functional. Noted: Cricket appear to have been added later. A cricket is installed behind any chimney stack that is 30 or more inches wide. It diverts any water that would otherwise accumulate behind the chimney and leak around the installed flashing. It is recommended that one be installed.

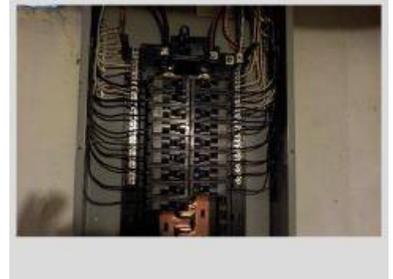
Main Panel Location:	Basement.
Panel Conditions:	Appears serviceable. RECOMMENDATION: No space between the panel and wall was noted. In according to the NEC, electrical panels should be provided with at least a 1/4 inch space on outside walls, we recommend at least 1/2 Inch be provided. This will help guard against corrosion and moisture from entering the panel.
Manufacture:	Siemens. Circuit breaker system.
Panel Service:	100 amp. Rating - 100 amp Max.
Grounding:	Grounding system appears serviceable. Grounding system noted at - bus bar, water pipe or meter, ground stake.
Inspectors Notes;	Main breaker was noted in panel, not tested. Circuit and wire sizing correct so far as visible. Panel is with the benefit of complete labeling list. Room was noted in panel for expansion of circuits.
120 Volt Circuits:	Number of 120v circuits - 15.
240 Volts Circuits:	Number of 240v circuits - 1.

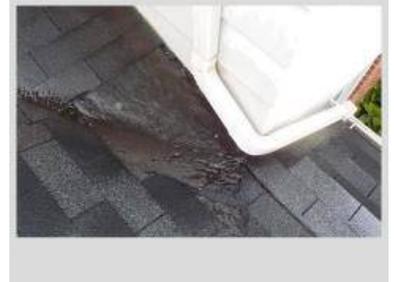
Type & Age: Asphalt composition shingles. These consist of cellulose mat, asphalt impregnated with colored gravel on surface. Composition shingles, two layers is noted. Approximate age of roof in years is - 6 to 8.

Roof Covering & Condition: TYPICAL MAINTENANCE RECOMMENDED. This usually consists of repair/replacement of damaged/missing shingles. This maintenance should help insure the weather tightness of the building and should be performed on a regular basis. A licensed roofing contractor should be called to make further evaluation and repairs as needed.

TYPICAL MAINTENANCE RECOMMENDED. This usually consists of repair/replacement of damaged/missing shingles.

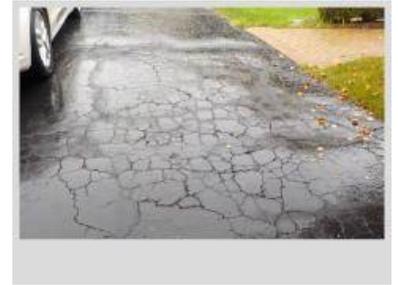
Type: Asphalt.
Condition: Spalling /Erosion to the surface is noted. Replacement/Re-surfacing required now or in the not to distant future. Obtain preliminary estimates.
